PA/DE ASLA AWARDS

2023 Professional Design Awards Program

Hershey's Mill Park
Dam Removal & Stream Restoration

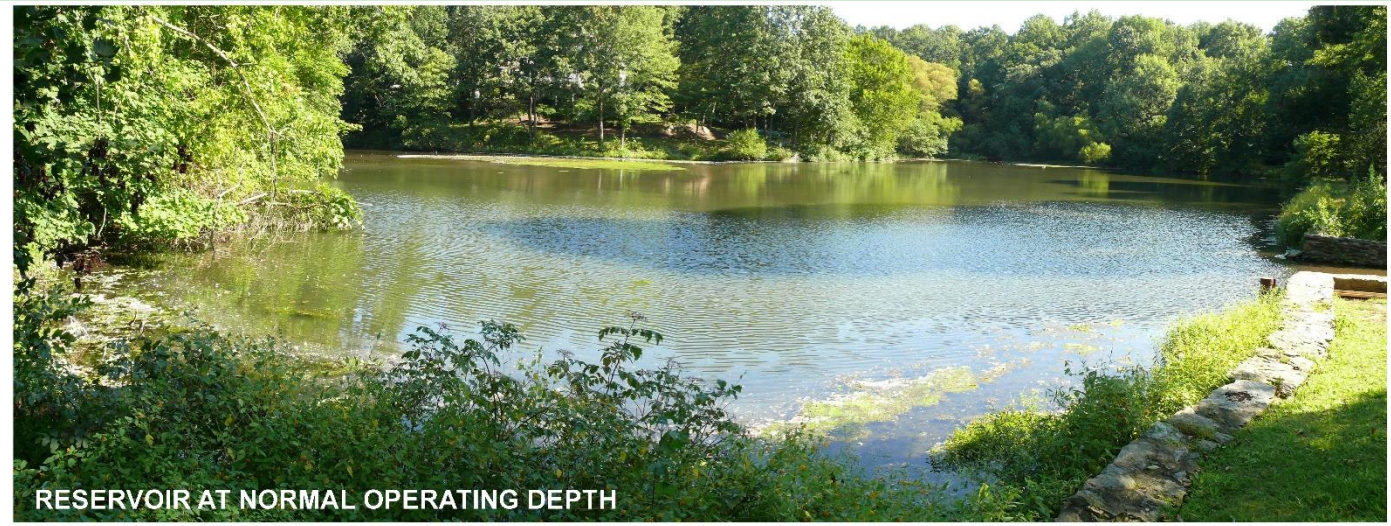
RESERVOIR AT NORMAL OPERATING DEPTH

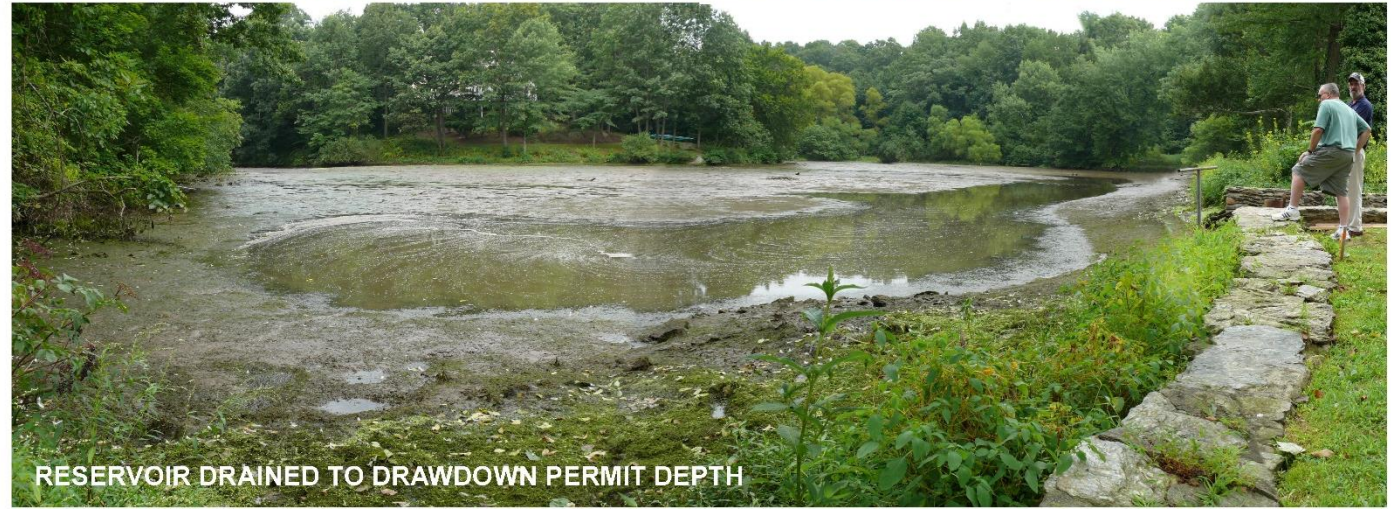
RESERVOIR DRAINED TO DRAWDOWN PERMIT DEPTH

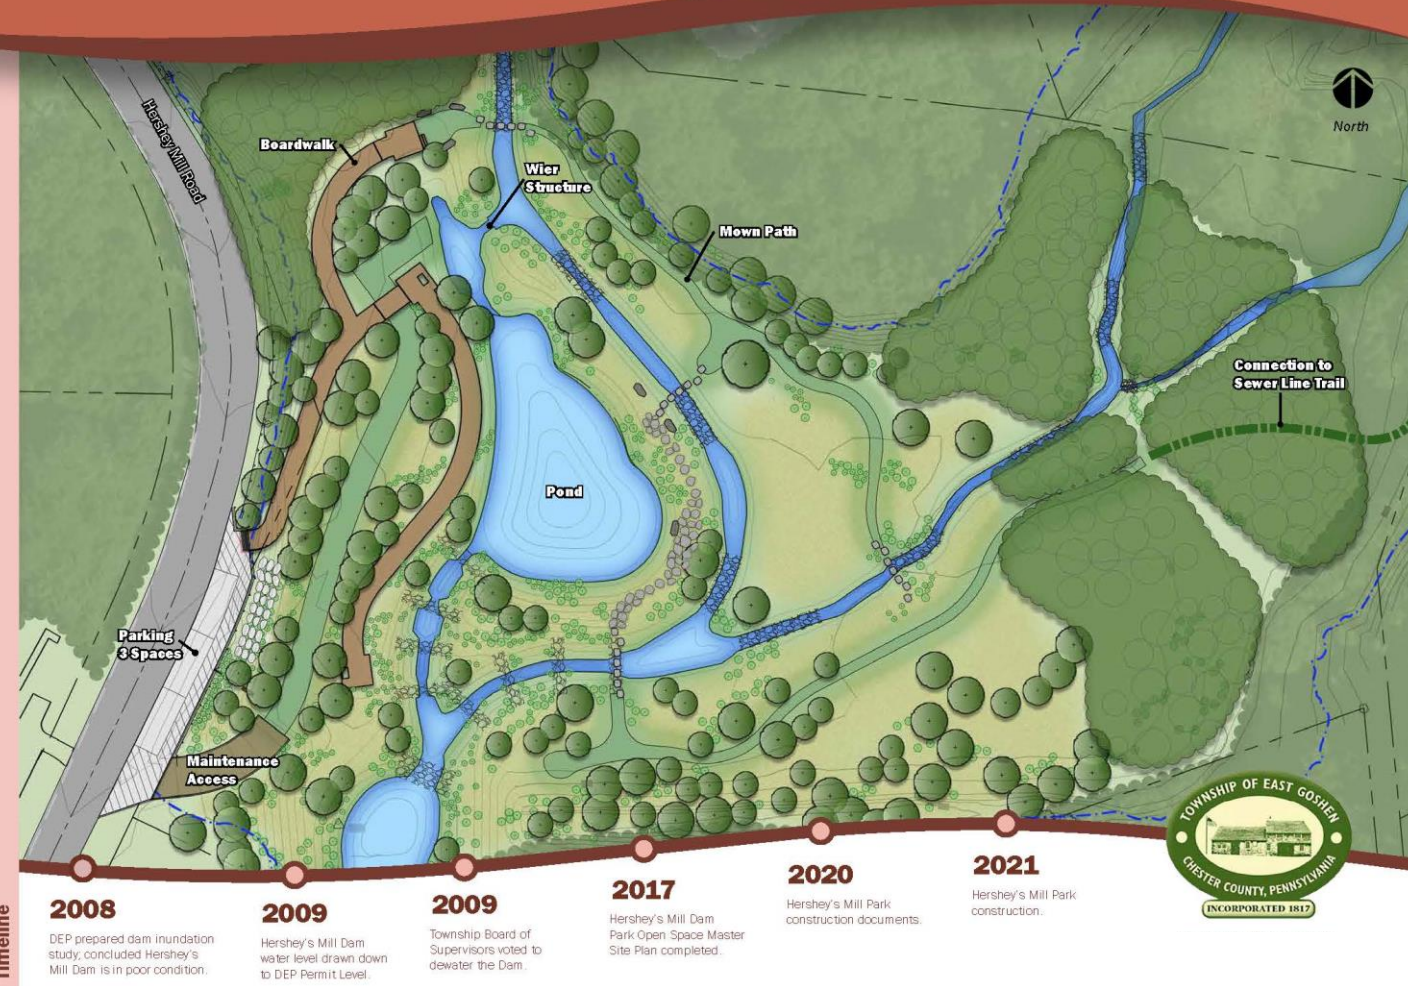
The master plan design by the landscape architect that was the basis for construction documents by the landscape architect / engineer team. This is also one of the interpretive signs installed in the park.

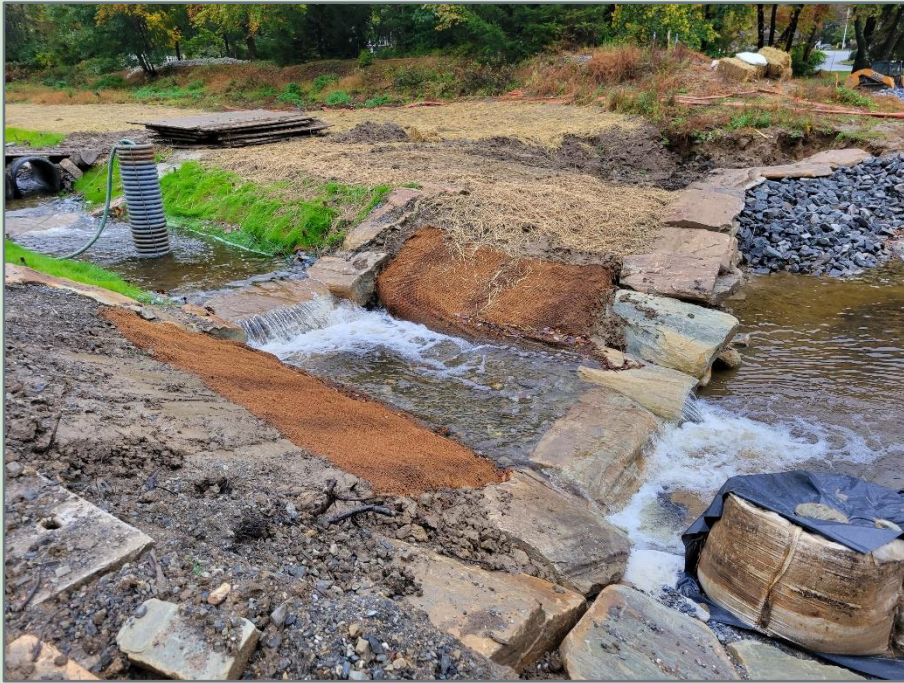
In order to lower the creek to the bottom elevation of the former dam in a sustainable manner, a series of step pools were created along the two reaches of the creek. This also allowed the construction of the pond to be accomplished cost-effectively since this required that legacy sediments be retained on site.

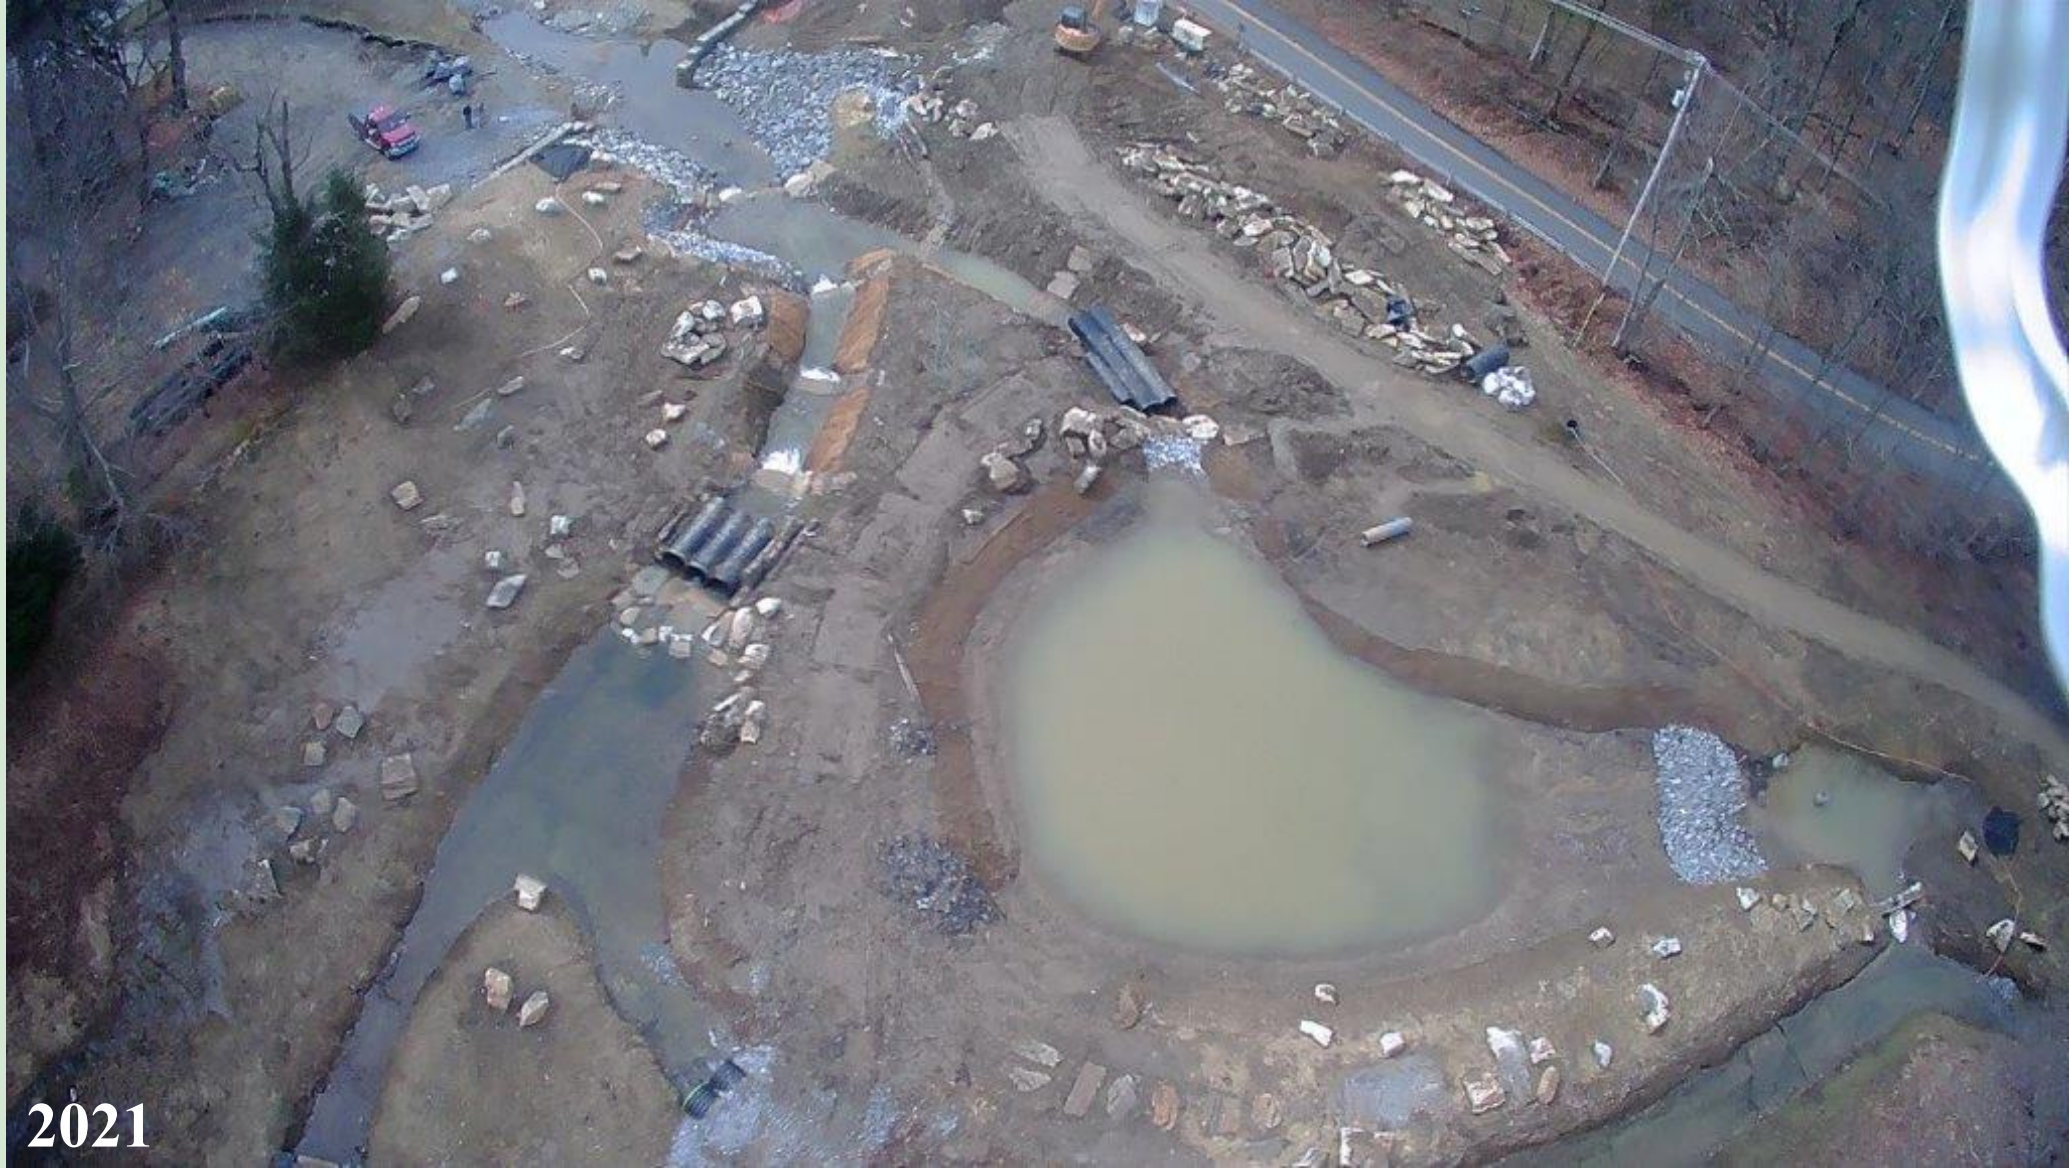
2021

Drone photograph of the park under construction with dam wall remnant at upper left. Pond in center with forebay to the right. A weir below the forebay spins water into the pond in controlled manner from the primary stream reach in the lower right.

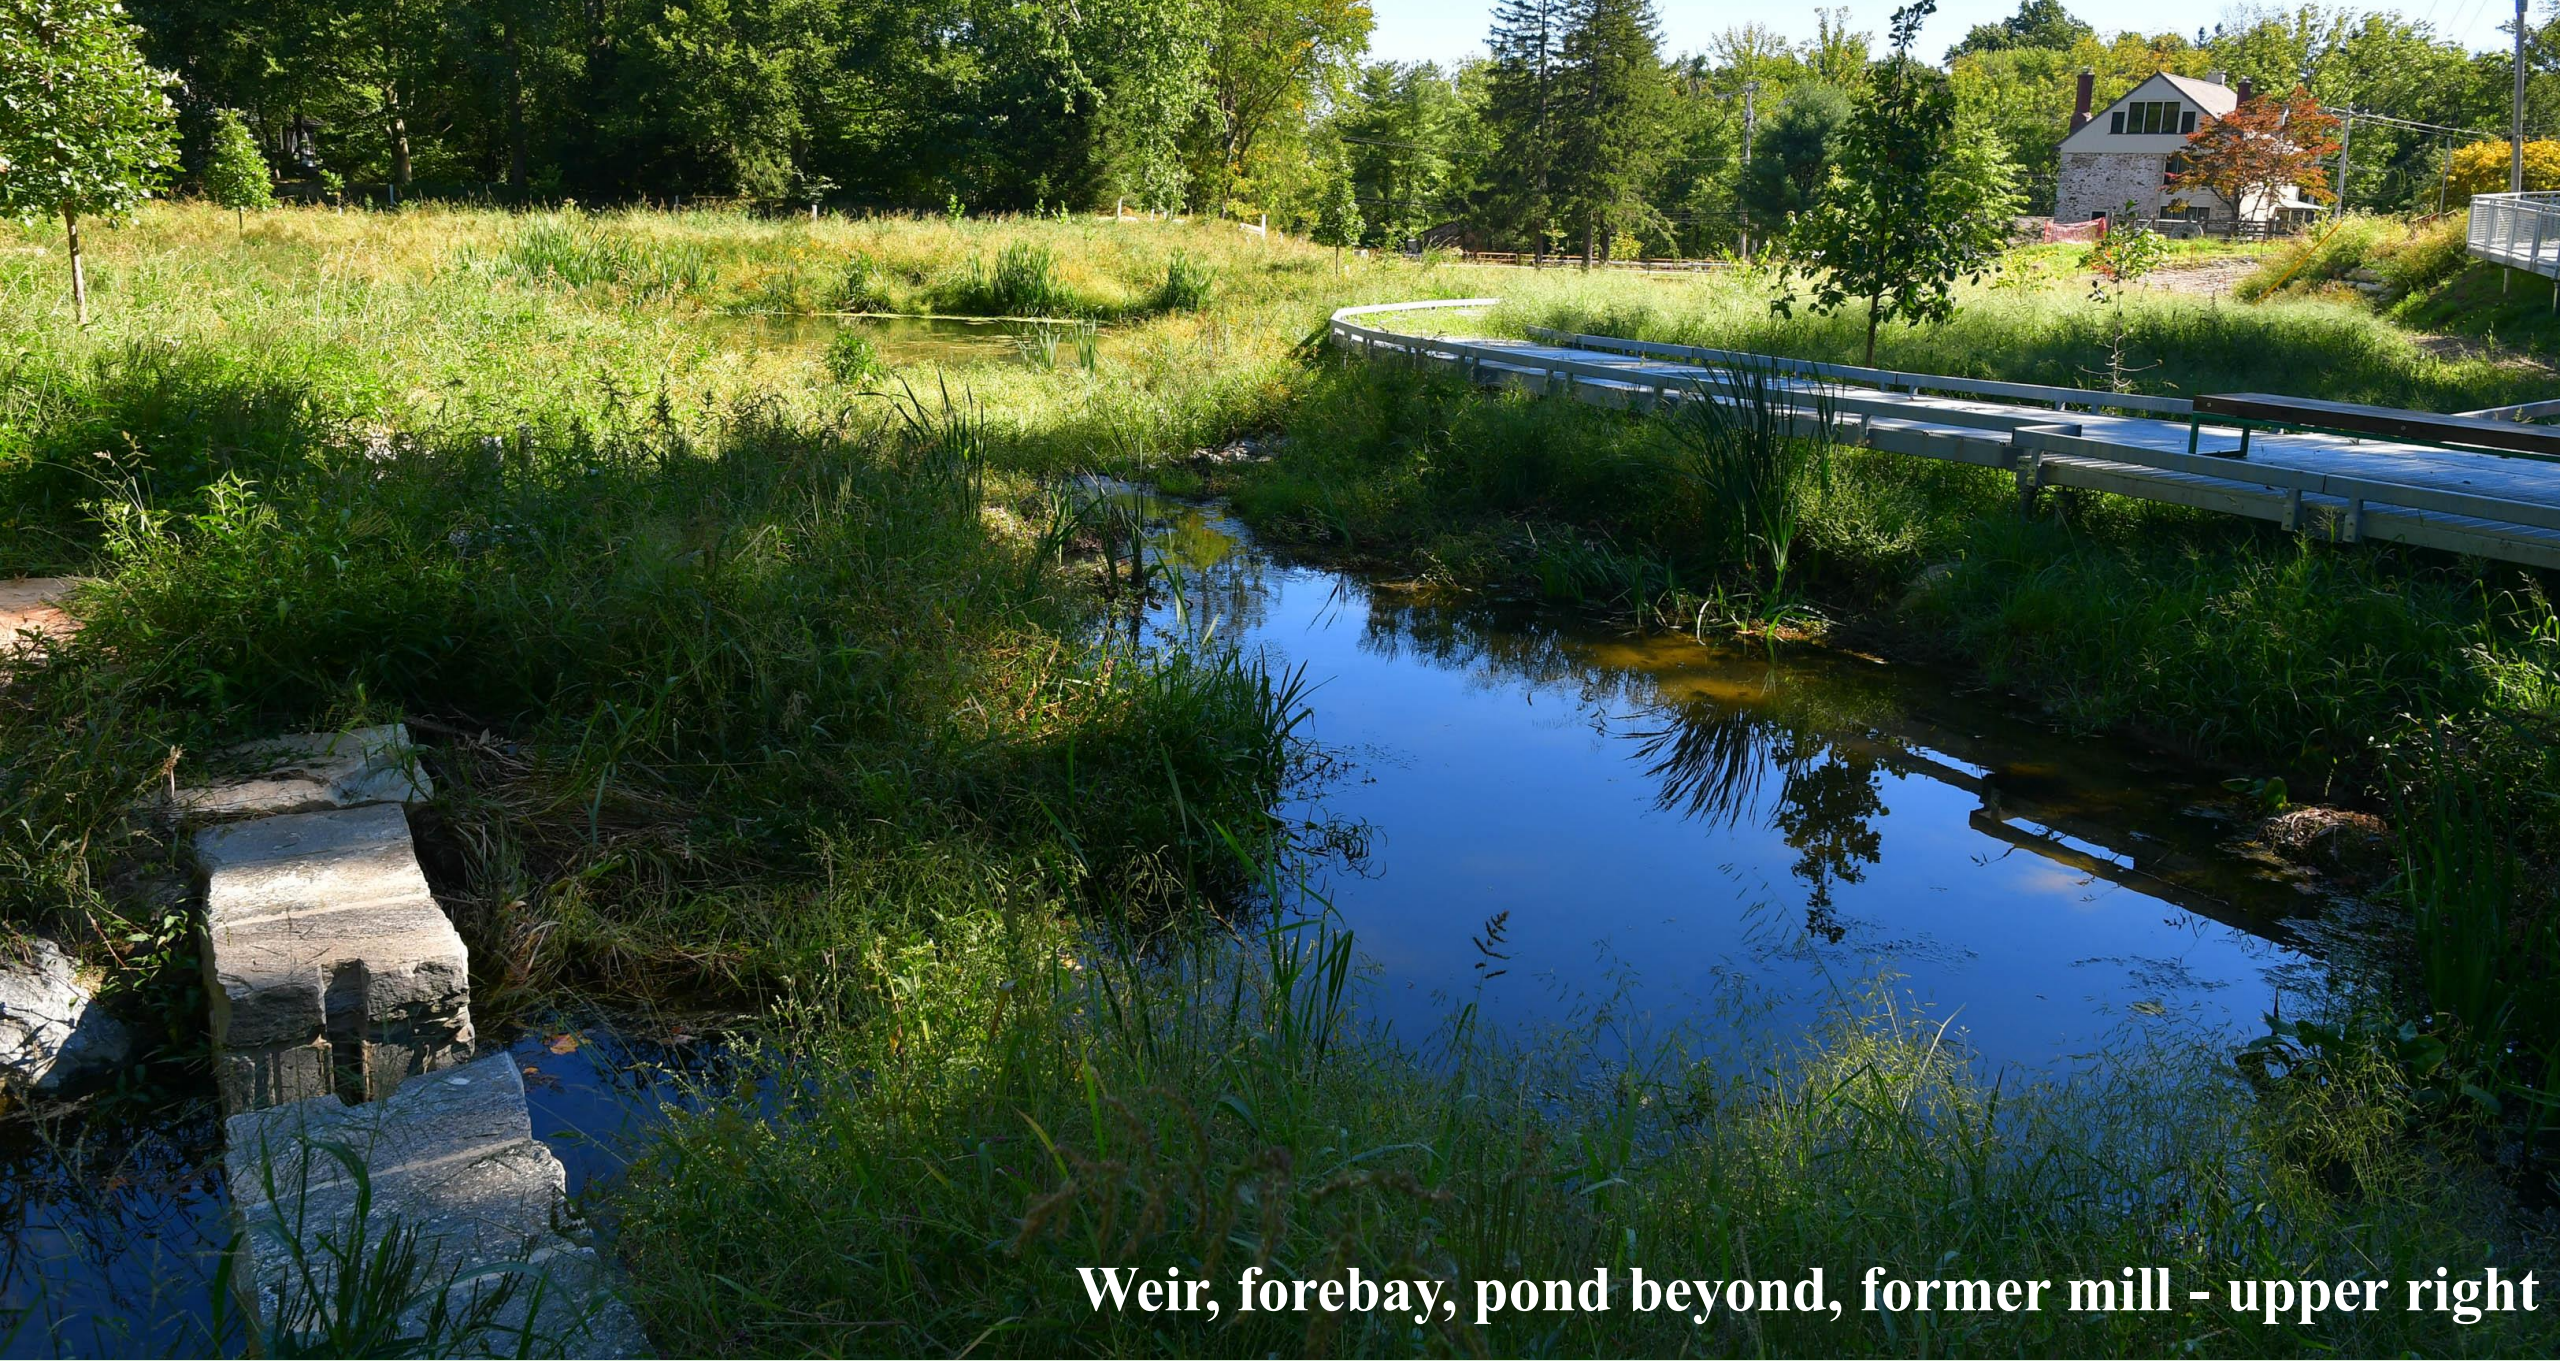
Weir, forebay, pond beyond, former mill - upper right

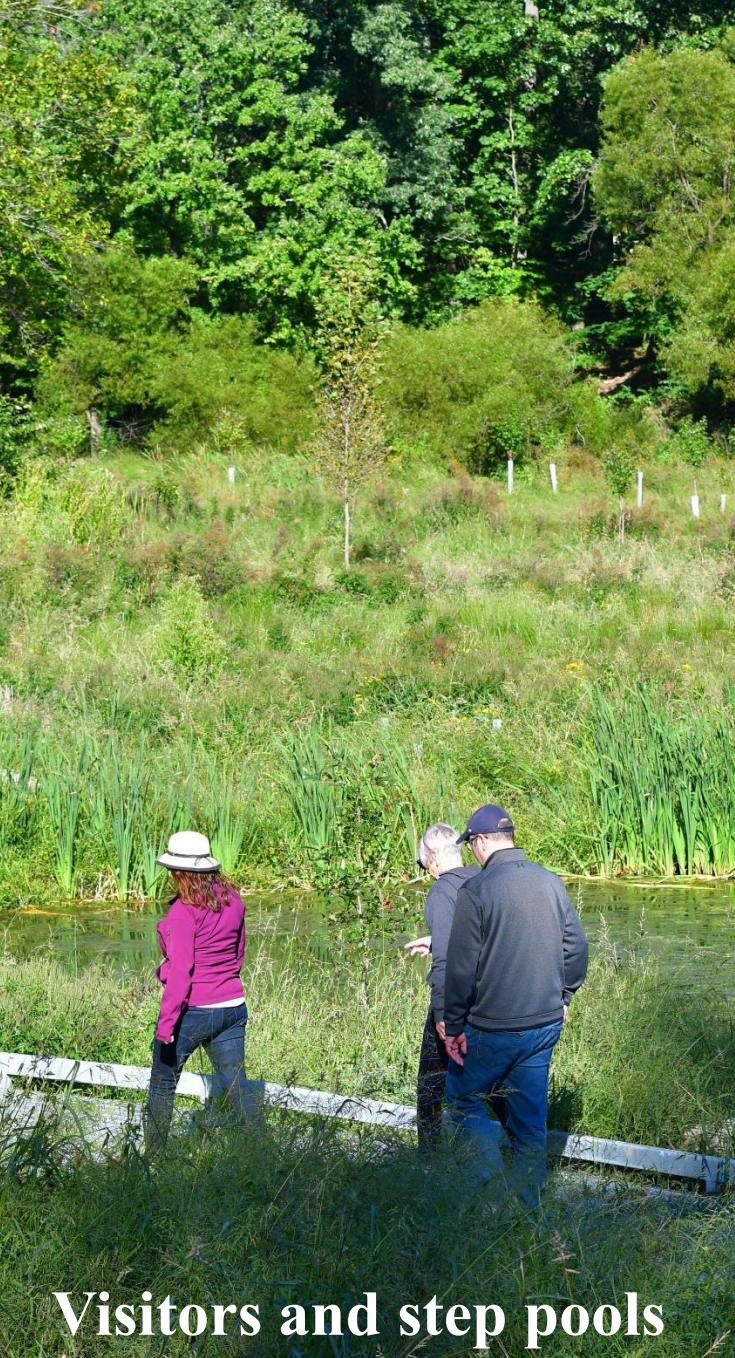
Visitors and step pools
